MO NONAME 408 LAKE DAM

OSAGE COUNTY, MISSOURI

MO 30580

PHASE 1 INSPECTION REPORT
NATIONAL DAM SAFETY PROGRAM

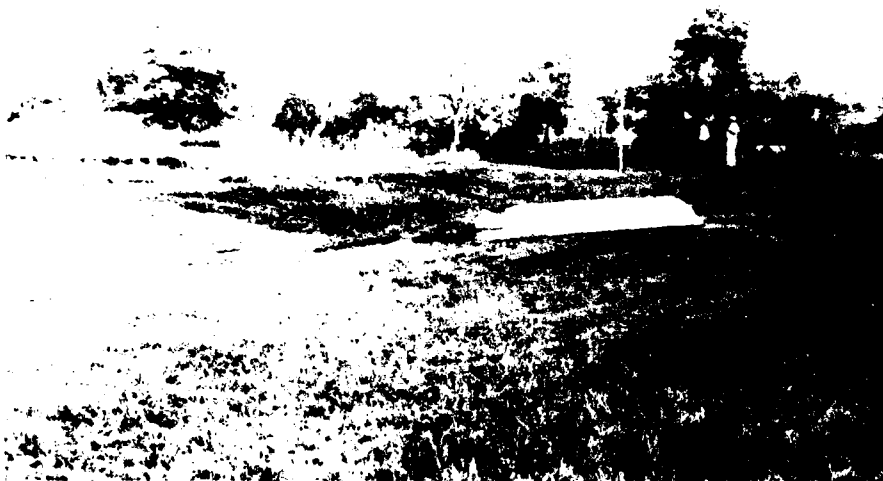
PHOTO NO. 3
LOOKING DOWNSTREAM
IN PRIMARY SPILLWAY
ON RIGHT ABUTMENT.
ROD ON CONTROL SECTION
AT CENTERLINE OF DAM.

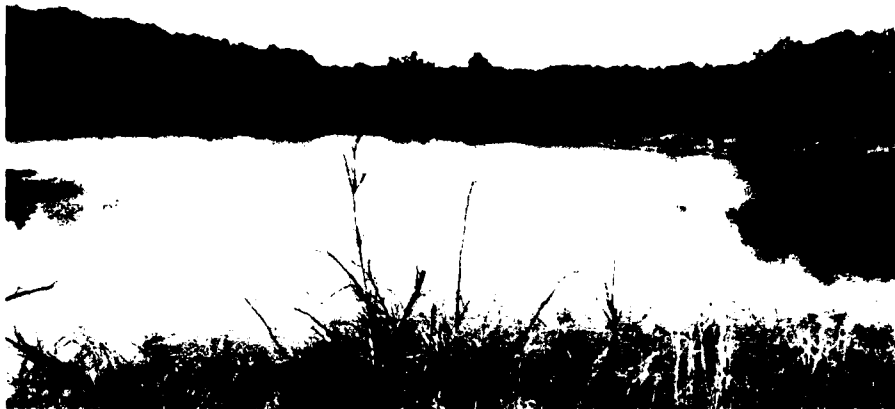
PHOTO NO. 5
LOOKING UPSTREAM FROM
CENTERLINE STATION 4+00±

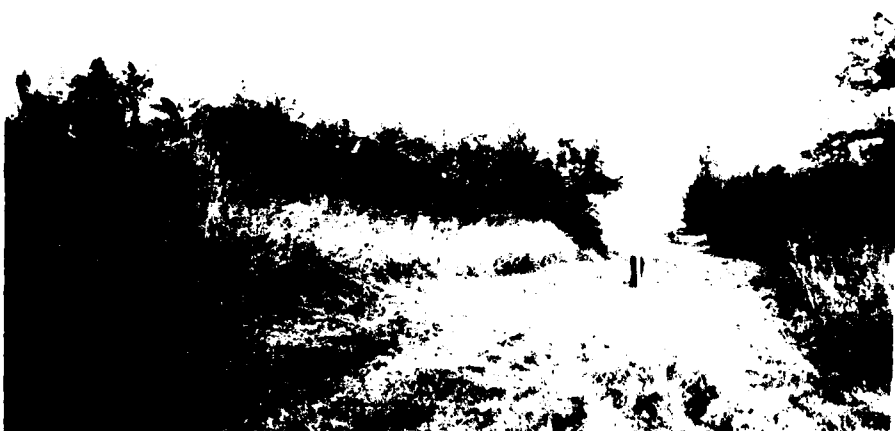
PHOTO NO. 6
LOOKING DOWNSTREAM
IN RIGHT EMERGENCY
SPILLWAY EXIT CHANNEL
